## Firmware change-log of new features and bug fixes of the u-remote IO-Modules:

### Firmware updating Information:

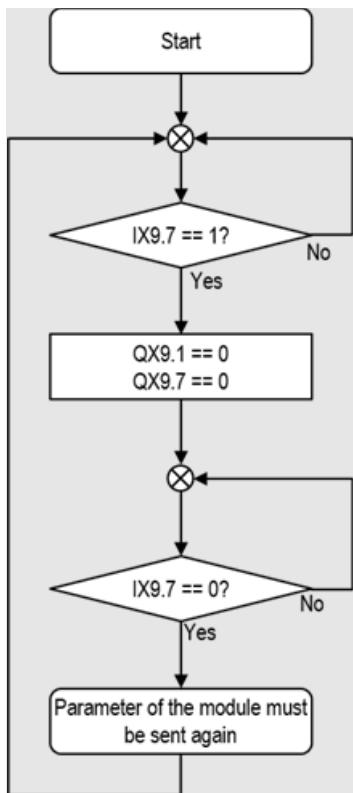
- **Known issue:**  
Non-simultaneous power cycling of external power supply and u-remote system supply while a motor is rotating could lead to unwanted motor movement:
  - A power cycle at the external power supply while the u-remote system supply remains causes the motor to stop and restart after external power supply is restored. The motor will continue moving to the target position of the last move command before the power interruption.
  - A power interruption of the u-remote system supply while the external power supply remains causes the motor to continue to rotate to the target position of the last move command.

- Workaround:  
The application program of the connected controller (PLC) should check the status of the process data bit "State power supply" (IX9.7). If the "State power supply" bit is "false" (0) the program should reset both the bit "Moving" (QX9.1) and the bit "Enable motor driver" (QX9.7) to "false" (0).  
(please see UR20 Stepper motor module manual)
- This behaviour is planned to be fixed with the next firmware update.
