## WI-IO-9-U3 Firmware Downgrade to WI-IO-9-U2 Procedure

### Purpose

This procedure explains how to downgrade the WI-IO-9-U3 firmware to the older legacy WI-IO-9-U2. The downgrade is performed by applying the appropriate firmware files using the USB thumb drive that is provided in the box with the radio. This procedure applies to both 900Mhz and 869Mhz models.

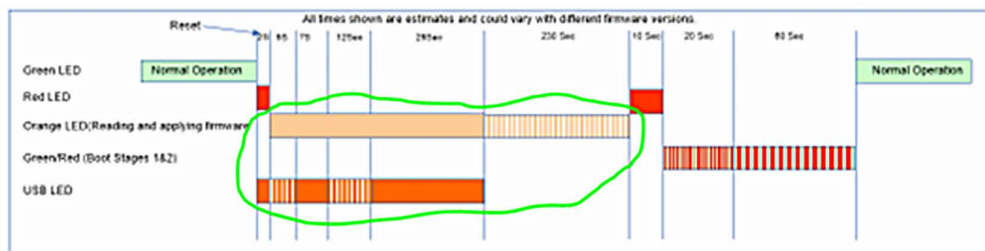
- Remove the USB drive from your computer and plug it into the USB port on the module, then reset power to the module. The radio will reboot and the firmware from the USB drive will be loaded.
- Follow the LED sequence in the diagram below. You should see the LED on the USB start flashing and a long solid ORANGE PWR LED on the Radio. Please wait until you see the PWR LED start to flash ORANGE, then go to step 7 below.

Figure 1. WI-IO-9-U3 to WI-IO-9-U2 PWR LED Sequence during Firmware Downgrade

- If the USB LED is not flashing and/or the radio PWR LED skips the long solid and flashing ORANGE, but flashes RED/GREEN instead, this means it has not read the USB drive. If this occurs, try the process again by removing and reinserting the USB drive, then cycle power to the radio. If the issue persists, please contact Technical Support.
- You can now remove the USB (this can be removed at any stage during the PWR LED flashing ORANGE or RED/GREEN). Let the module go through the full process which can take 8-10 minutes. This may include another reboot depending on the firmware version and when the USB is removed.  
**NOTE: MAKE SURE POWER IS NOT INTERRUPTED DURING THIS PROCESS OR THE MODULE MAY BECOME UNSERVICEABLE.**
- After the upgrade, the PWR LED should be ON solid GREEN and the RS485 LED will be flashing, this indicates the module has successfully downgraded to a WI-IO-9-U2.

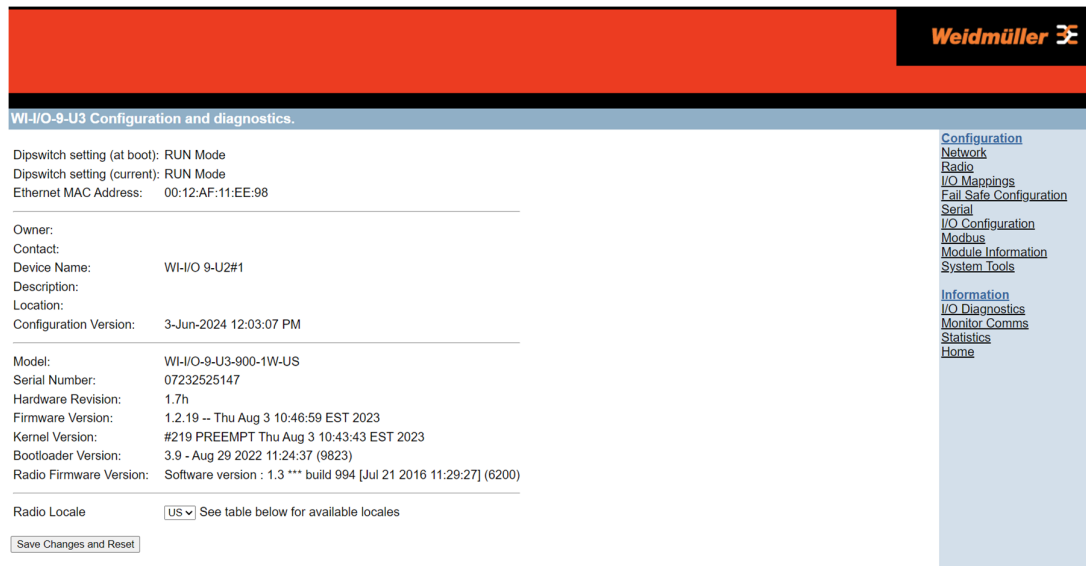
3. You should be greeted with a web page similar to the one below.

The screenshot shows a web interface for a Weidmüller device. At the top right is the Weidmüller logo. Below it is a blue header bar with the text "WI-I/O-9-U3 Configuration and diagnostics." The main content area is divided into two columns. The left column contains configuration and diagnostic data, and the right column contains a navigation menu.

When completed, review the web homepage to confirm the firmware has been downgraded.
